Considerations for Determining Safe Separation Distances from Mass Fires: a Literature Search

Thomas L. Boggs
Jacobs Naval Systems Group, Ridgecrest, CA 93555

Josephine Covino
*Policy Development Division
Department of Defense Explosives Safety Board, Alexandria, VA*

2010 DDESB Seminar

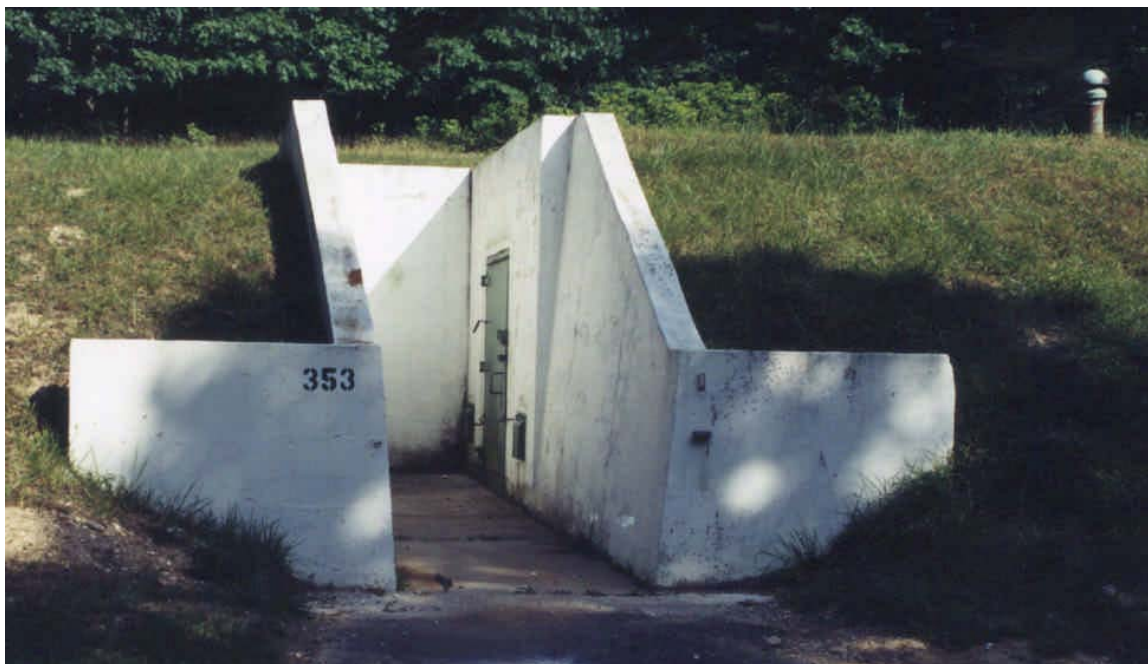
FIGURE 3. Magazine Similar in Design to One Destroyed at White Oak, Maryland, 28 June 1992.

Two explosions destroyed an earth-covered magazine similar to the one shown in Figure 3.

The magazine contained 5,180 pounds of largely HD1.1 materials. Fire was caused by decomposition of experimental energetic material, followed 2 minutes later by detonation of the other energetic materials. The magazine was destroyed. Debris including pieces of concrete 1 to 2 feet in diameter was thrown up to 800 feet. Smaller pieces of debris (concrete pieces up to 4 inches in diameter) were thrown as far as 2,000 feet.

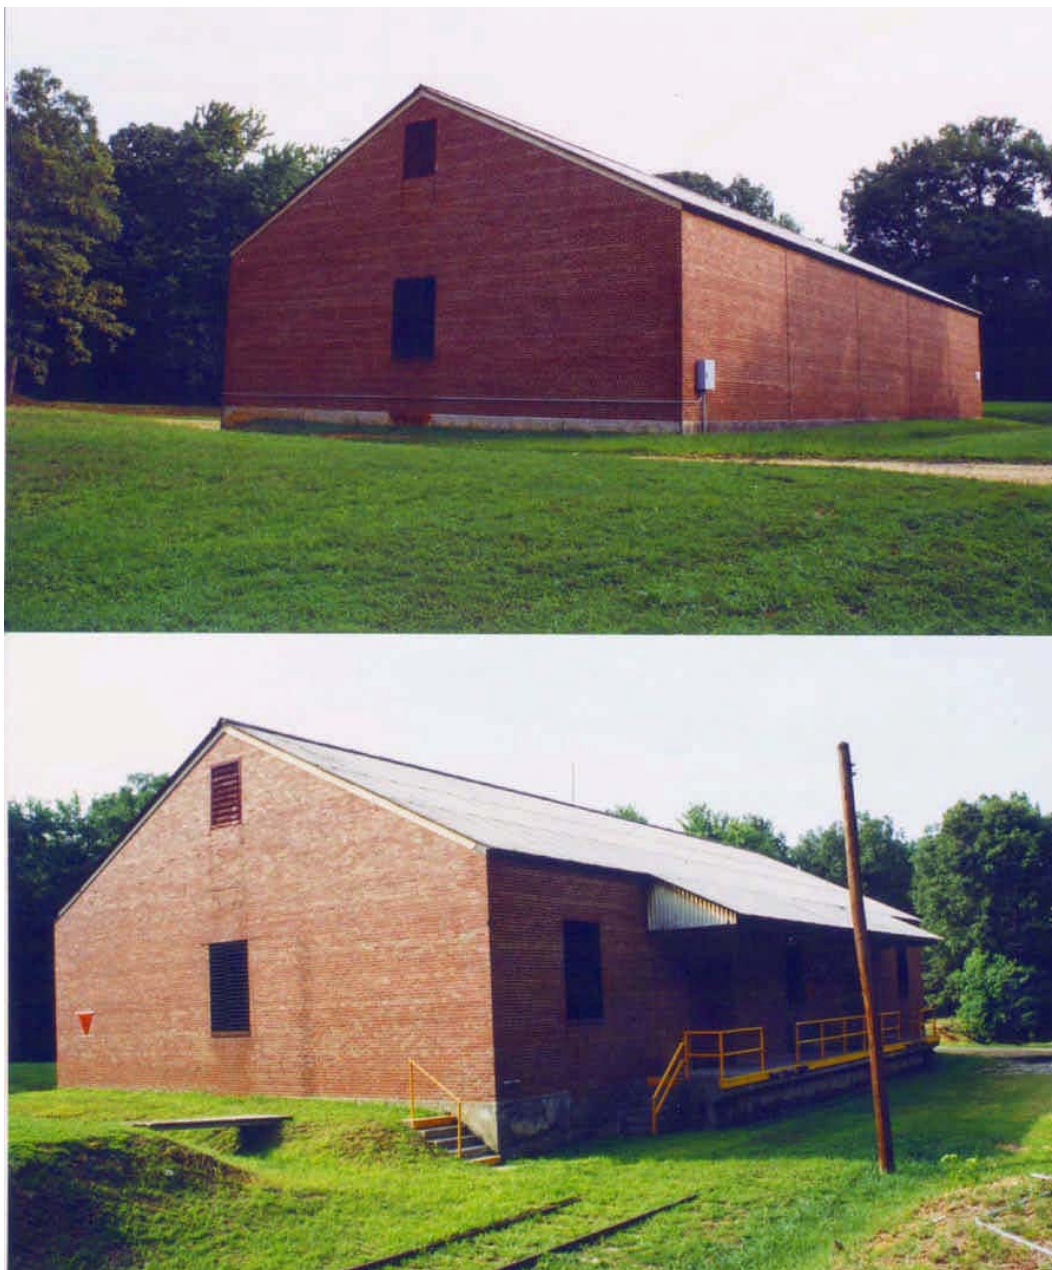
FIGURE 4. Magazines Similar in Construction to Magazine 518, Indian Head, Maryland.
The structure after the fires and detonations is shown in Figure 5.

This accident occurred in a non-standard, above ground, non-barricaded structure similar to the ones shown in Figure 4.

The magazine was sited for storage of 500,000 pounds of HD1.3 materials. At the time of the accident, there were 93,522 pounds of HD1.3 material and 4,609 pounds of HD1.1 material. Most of the materials were bulk powders and propellants for cartridge-activated devices or propellant-activated devices (CAD/PAD). The HD1.1 material in the magazine was pyrotechnic/propellant material for which the hazard classification was in question. Later analysis determined it was HD1.1.

The surmised sequence of events started with auto-ignition of nitrocellulose gun propellant. The fire spread and involved a relatively large quantity of magnesium-teflon-viton flare material, which provided an intense boost to the fire. This in turn led to the first and largest detonation followed by a series of smaller detonations.

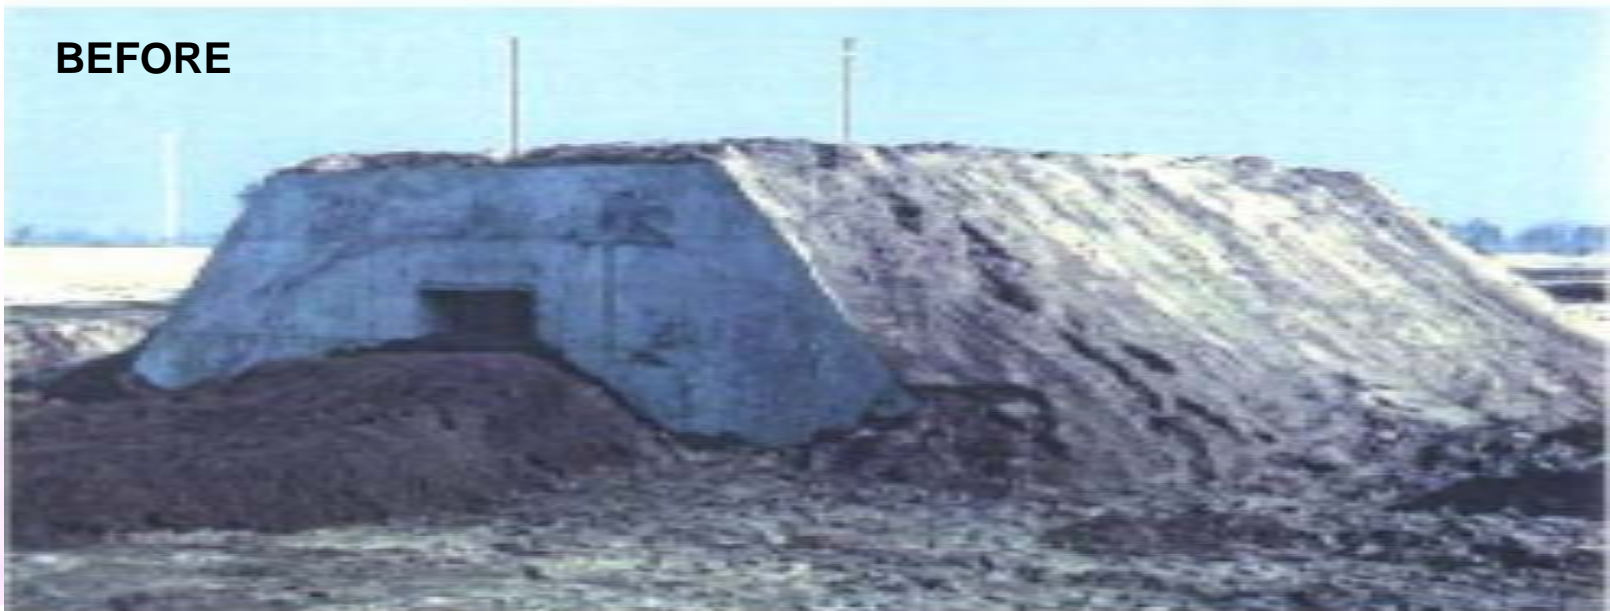
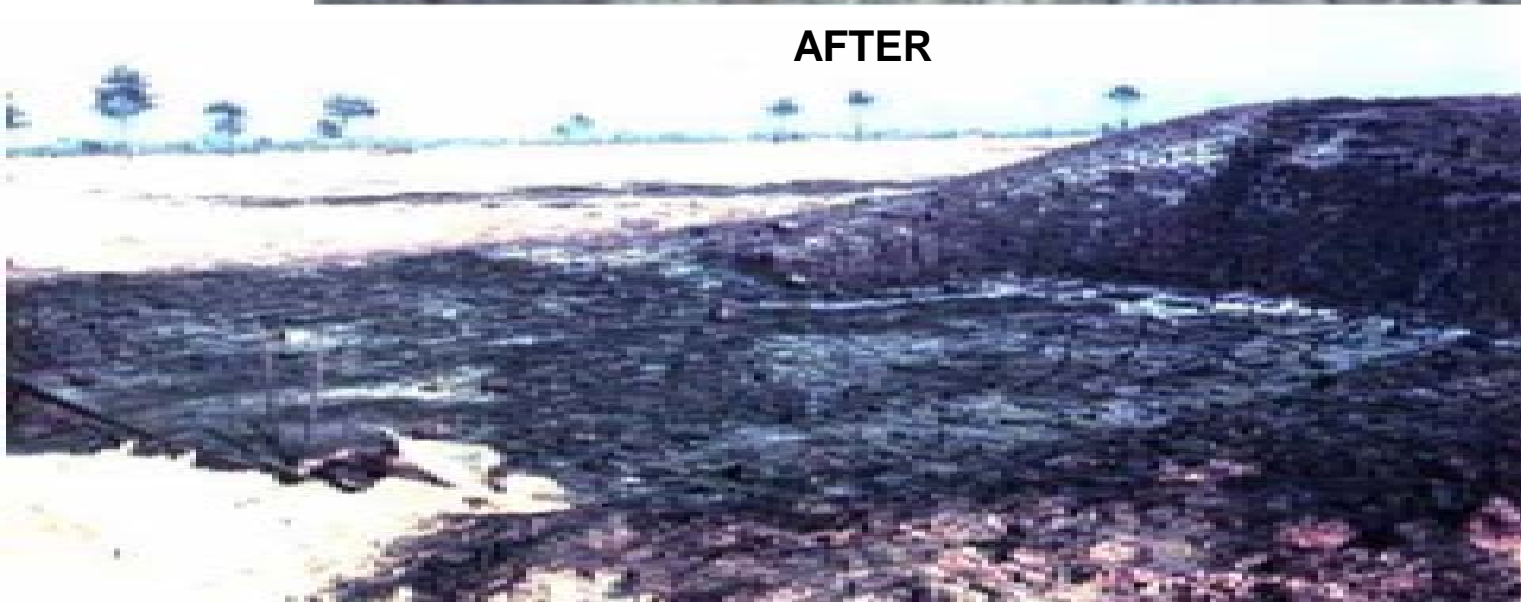
Allain Test 4

Test 4 resulted in the igloo bursting 1 second after ignition, releasing a fireball. At ground level, no trace of a plume was observed. The igloo separated along its structural lines or corners. It separated into five main parts, each comprising two pieces—one concrete and one steel as shown in Figure 21.

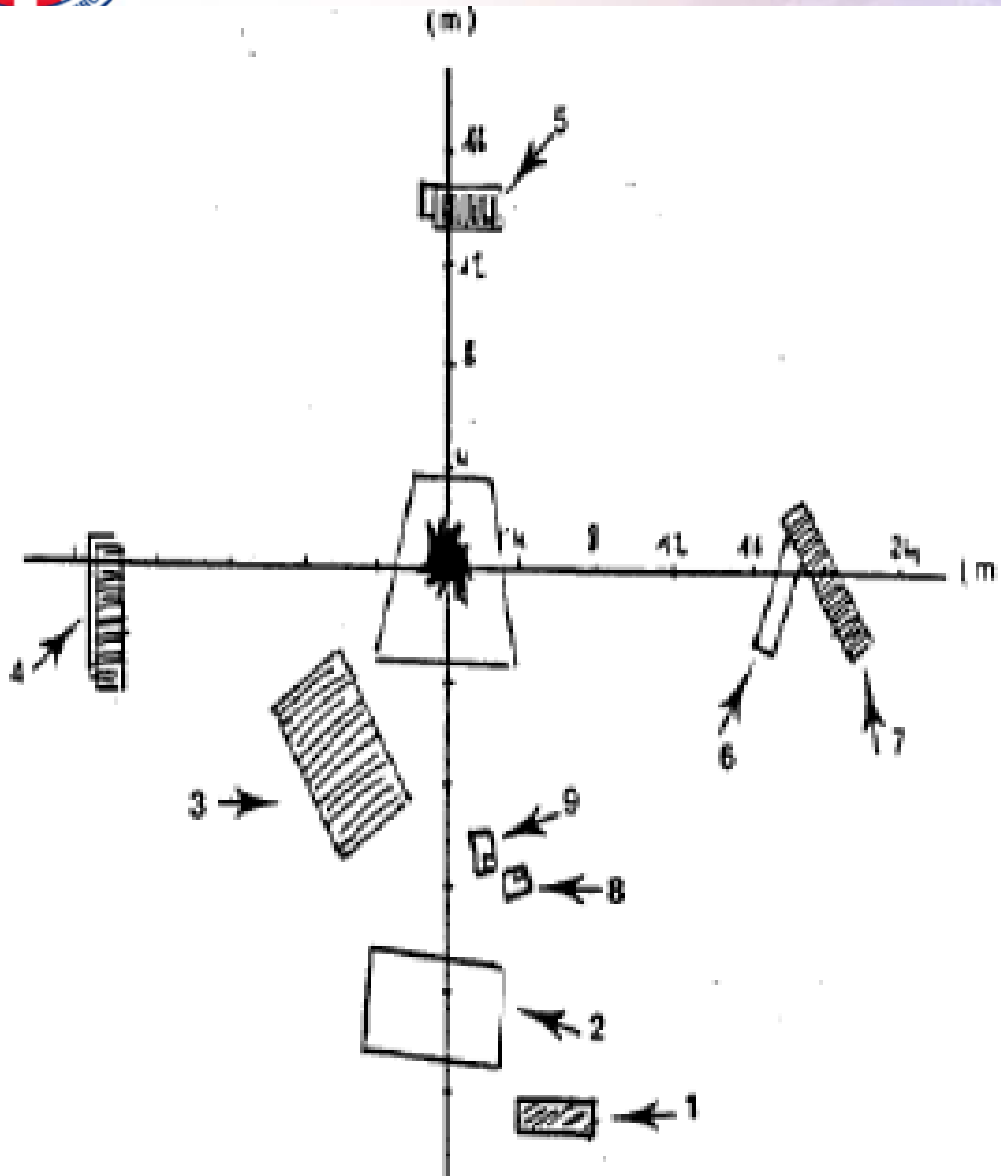
Allain Test 4

- 1 metal front
- 2 concrete roof
- 3 metal roof
- 4 lateral metal + concrete wall
- 5 rear metal + concrete wall
- 6 lateral concrete wall
- 7 lateral metal wall
- 8 1/2 concrete front
- 9 1/2 concrete front
